Manhole Inspection Summary

Manhole # S69M__014MH

Insp Date: **1/29/08 10:55 AM**

Location Address: **6709 Graceland Ave.**

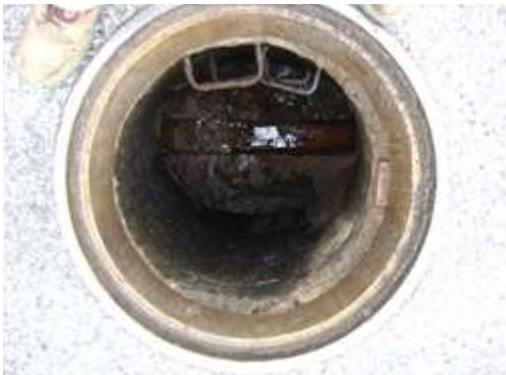
Defect 2

Condition: ☐ Sound ☐ Cracked ☐ Root Intrusion ☐ Loose Brick ☒ **Deteriorated**

Infiltration: ☐ None ☐ Joint ☐ Cracks ☒ **Mortar** ☐ Roots ☒ **Wall**

Infiltration on barrel wall through mortar

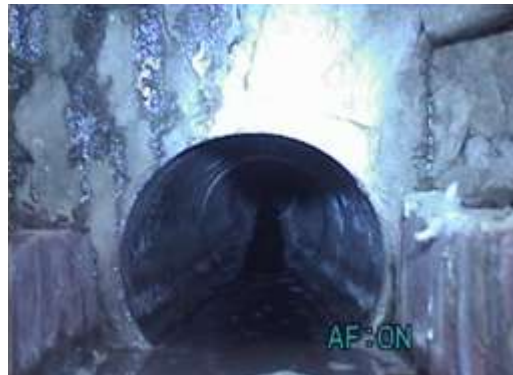
Defect 1

Infiltration in barrel wall above incoming 6 o'clock

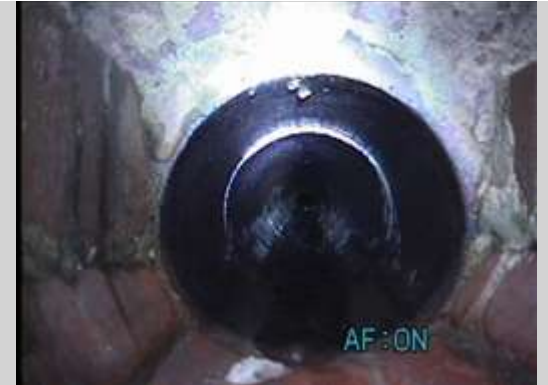
12 O'Clock Outflow

Pipe Height: **8.4** (in.) Rod and Bar (Angled)
Pipe Material: **Clay** ☐ Pipe Lined
Invert Depth: **8.63** (ft.) Flow Characteristics: **Slow**
Deposits: ☒ None ☐ Mud ☐ ~~Gravy~~ ☐ Debris ☐ Grease
Silt Depth: (in.) Deposits Extent:
Infiltration: **None** Pipe Seal Cond: **Sound**

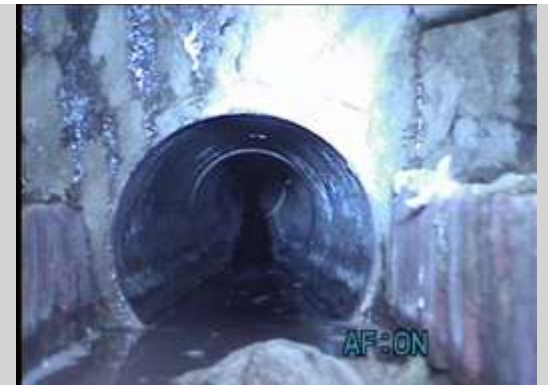
6 O'Clock Inflow

Pipe Height: **8.4** (in.) Rod and Bar (Angled)
Pipe Material: **Clay** ☐ Pipe Lined
Invert Depth: **8.54** (ft.) Flow Characteristics: **Slow**
Deposits: ☐ None ☐ Mud ☒ ~~Gravy~~ ☒ Debris ☒ Grease
Silt Depth: **2** (in.) Deposits Extent: **Medium**
Infiltration: **None** Pipe Seal Cond: **Sound**
